# TGB TECHNICAL BULLETIN

NO. CCP960411

**Topic:**  
**R50X stator (CDI)**

**Scope:**  
R50X model only.

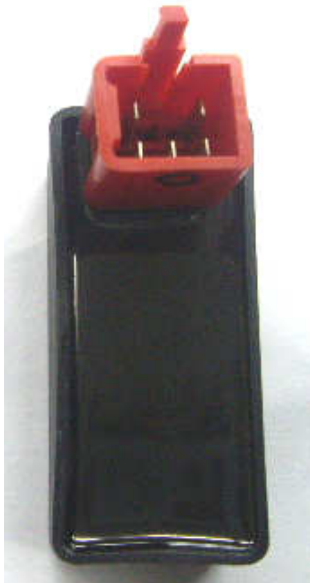
We received claims that our R50X scooter would suddenly turn off and then could not start anymore due to stator problem.

**Picture 1 :**  
**original CDI (P/N: GE5139902)**

1. Change stator supplier
2. To execute full inspection
3. Modify the CDI and replace.

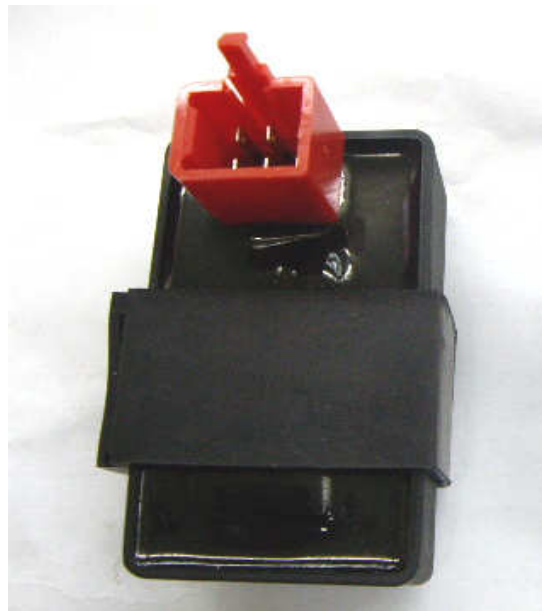
**Picture 2**  
**new CDI (P/N: 441019)**

After frame no. 642755 is a modified one
