TGB ALARM SYSTEM REMOVAL

We have found that in some cases it may be required to remove the Alarm system from scooter. Units that are affected are the 2006 R5, 2006 R9 and 2006 R50X.

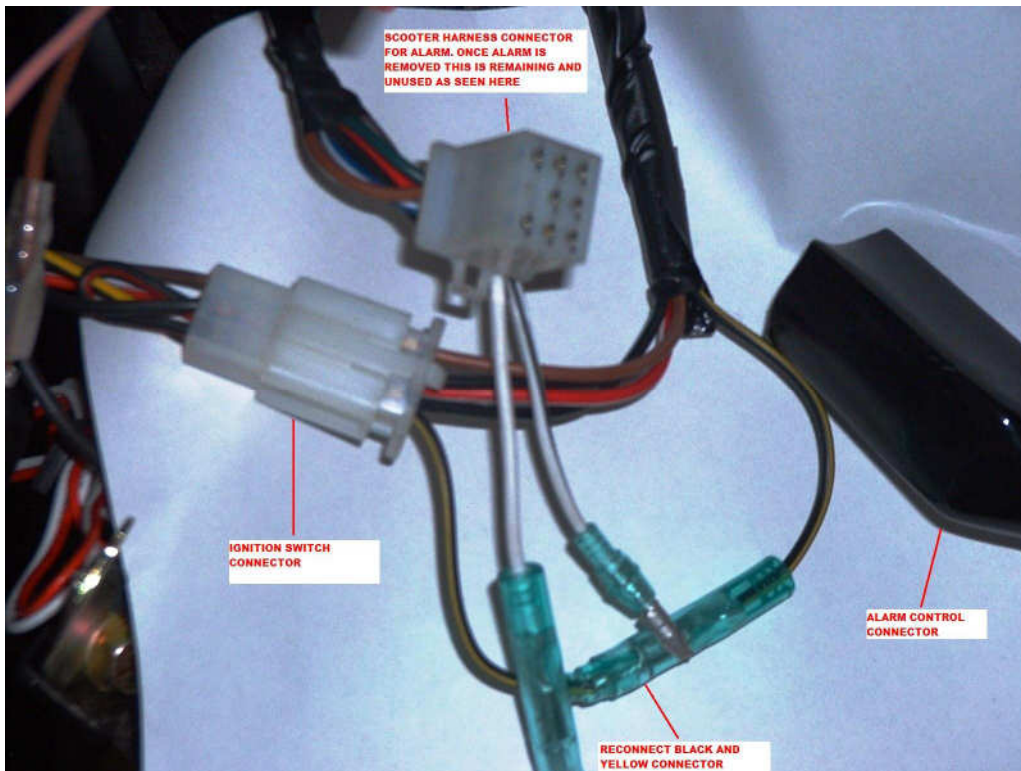
1. Remove the front headlight panel.
2. Locate and Identify alarm system.
3. Disconnect the nine pin connector and remove the alarm box, horn and ground wire.
4. Disconnect the 2 white and blue pin connectors from the black and yellow wire coming from the ignition switch.
5. Reconnect the 2 black and yellow pin connectors as shown in picture.
